Rock Island Arsenal Historical Housing Assessment Report

US Army Garrison Rock Island Arsenal
Rock Island, Illinois

Prepared By:
U.S. Army Corps of Engineers
Louisville, Rock Island and Seattle Districts

SEPTEMBER 2005

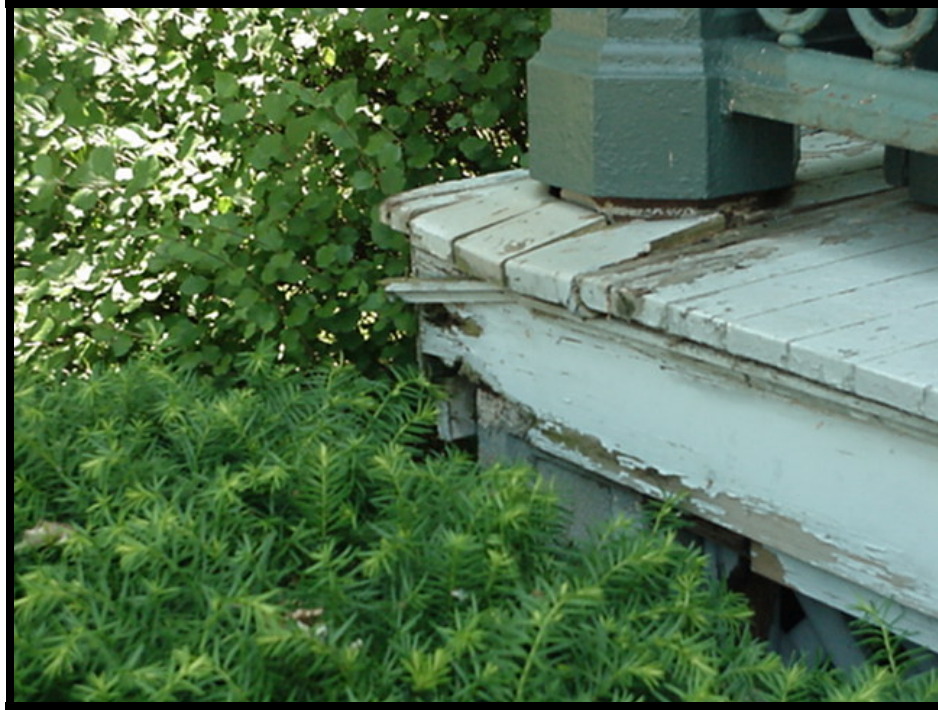
- The porches on these homes are sorely in need of new paint and repair work to the steps, decking, and in some cases, the supports. In year's past, screens were added to the porches to make them more usable. Unfortunately, the design of the existing screens has not allowed easy removal of water off the deck. This has caused some rotting of the deck boards, fascia, and support structure of the deck (See Figure 1). The porch screens need to be replaced with a new screen design that allows water to more easily be removed from the deck. The deck itself on most of these homes needs some repair and a coating of high quality paint. The ceilings also are in need of new paint as well as new lighting, preferably historic period reproduction lighting to enhance the historic features of the structures (See Figure 2). The roof materials on many of the porches are also in need of replacement.

Figure 1: Deteriorated deck boards

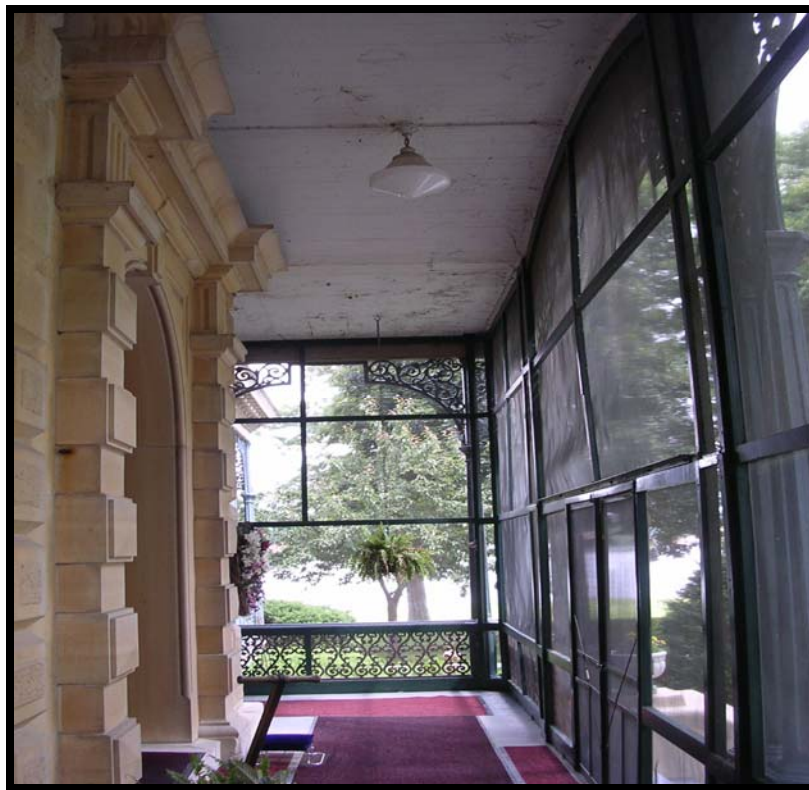
Figure 2: Quarters 1, Porch

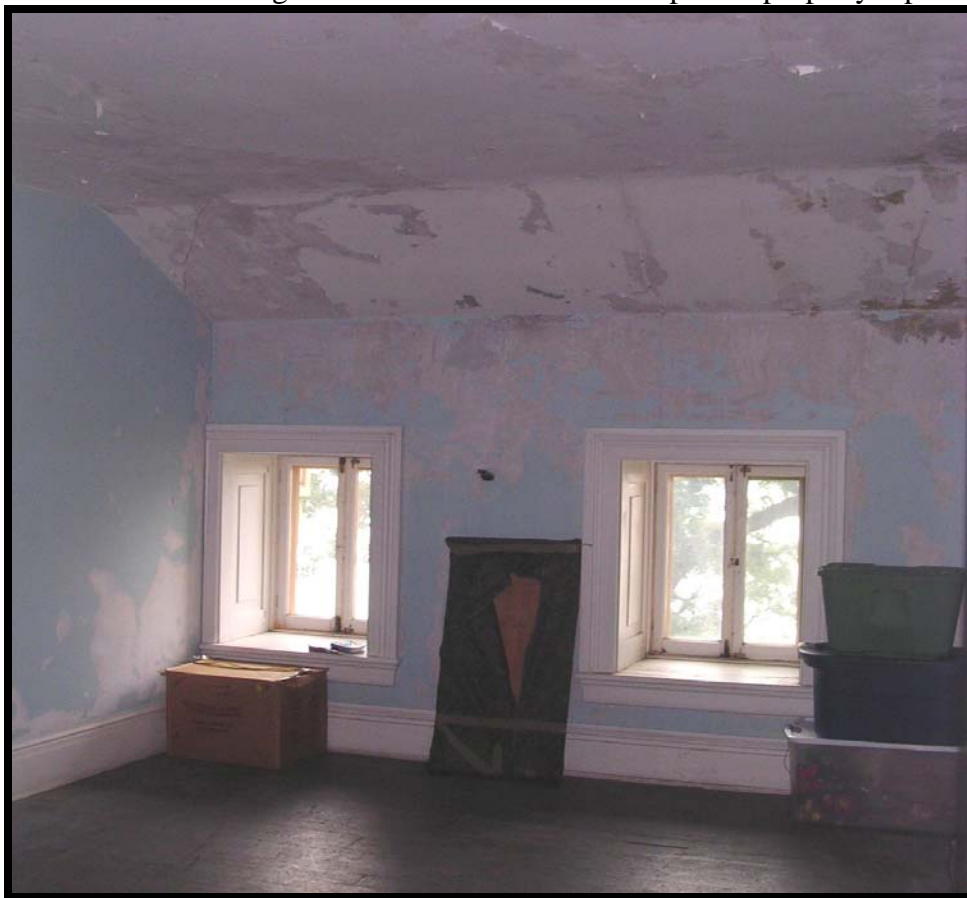
Figure 6: Quarters 1, Deteriorating wall and ceiling of 3rd floor

- The plaster walls and ceilings of the rooms on the 3rd Floor of Quarter's 1 are in the worst condition with major cracks and deterioration throughout (See Figure 6). Much of this is probably due to the area being closed off without proper climate control. The extremes in heat and cold are most likely the cause of the extreme damage to the plaster as well as other finishes on the 3rd floor of Quarters One. This issue needs to be addressed as soon as possible before much of the original fabric comprising the 3rd floor is beyond repair.

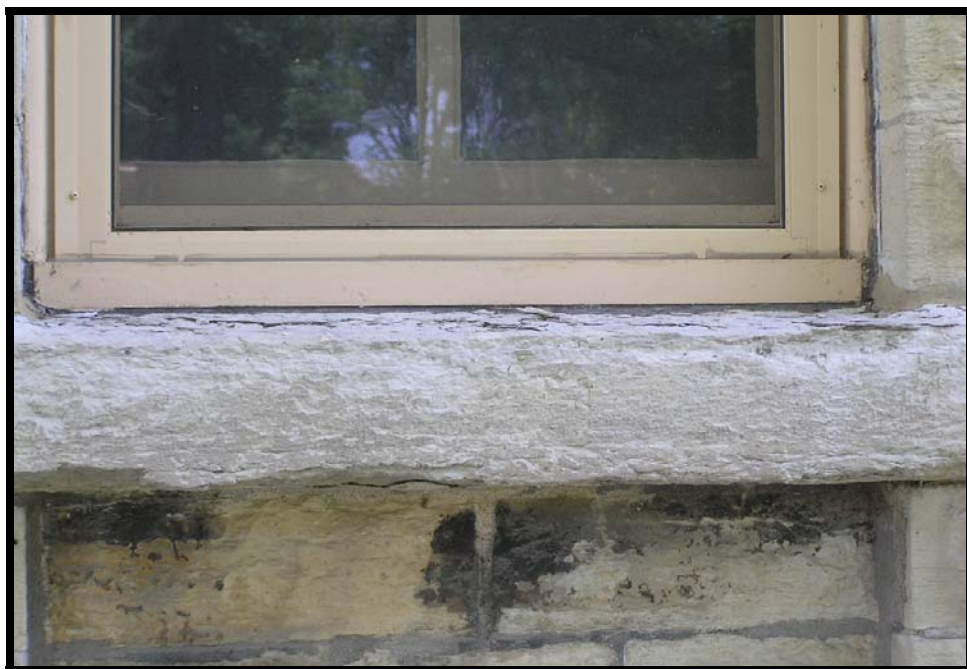
- The exterior stone and brick walls were generally in good condition except for the need of tuck-pointing 10-25 % of the joints in the walls and foundations.
- Many of the stone exterior porch steps and stone window sills (See Figure 10) were starting to delaminate. Repair is difficult, so steps and sills should be replaced.

Figure 10: Typical stone window sill deterioration

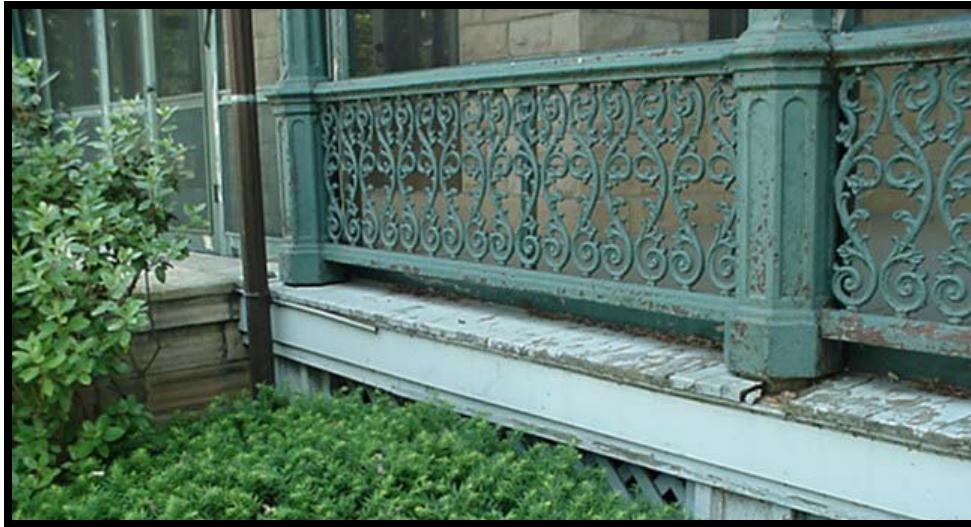
- The storm windows on the buildings are trapping moisture between the interior window and the storm resulting in peeling paint and deteriorated window caulk. Painting of the window trim and caulking of the window panes is recommended.
- In general, paint is peeling on all the porch trim including the wood floor, columns, iron supports and trim, and the porch screen framing (See Figure 11). The porch screening needs to be modified to allow water drainage off the porch floor.

Figure 11: Typical porch deterioration

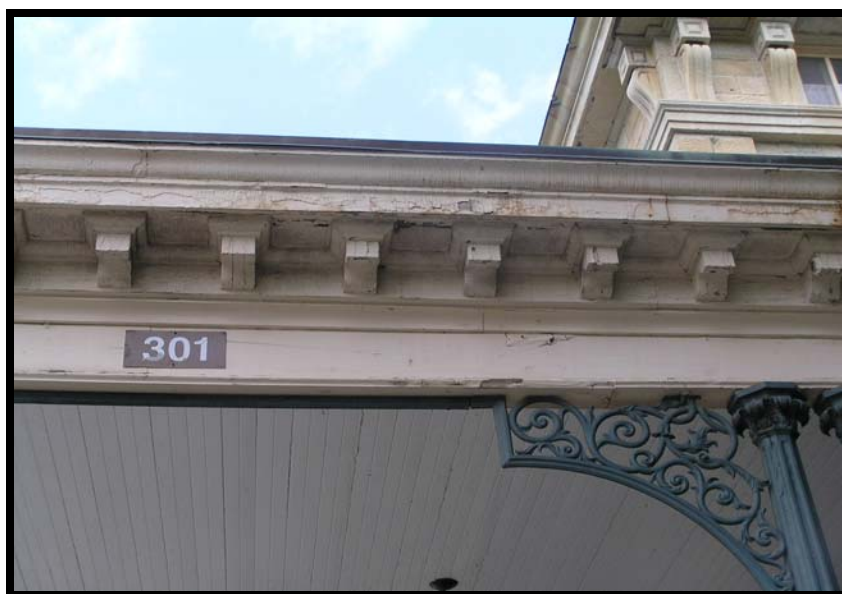
- The EPDM porch roofing has reached its life expectancy and should be replaced before major damage occurs.
- Wood soffits under the roof show signs of water damage as well as peeling of paint (See Figure 12). Leaks should be repaired and soffit material replaced and repainted.

Figure 12: Quarters 1, example of soffit deterioration

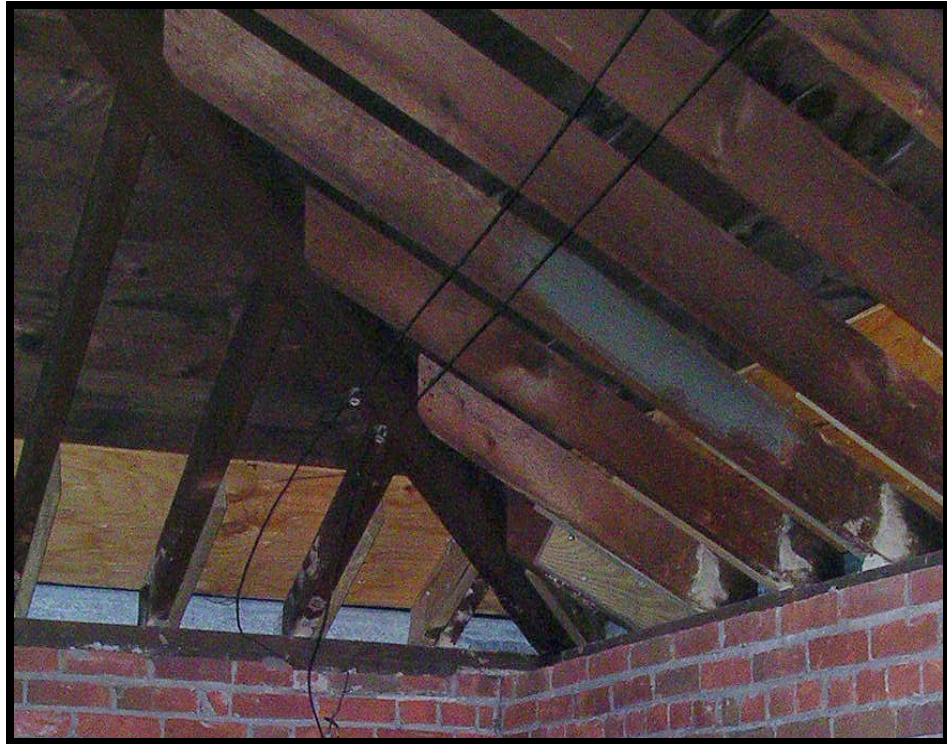
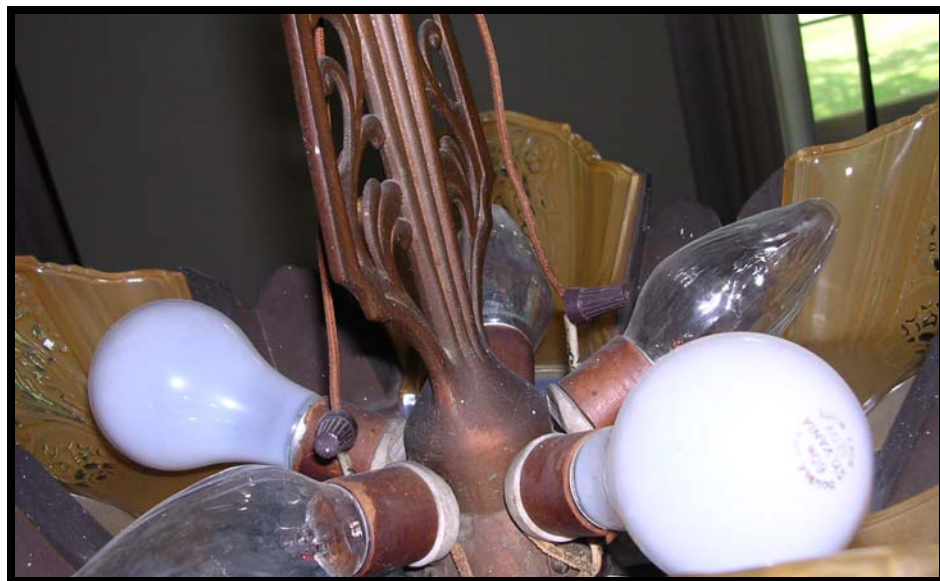
Figure 15: Knob and tube wiring, ex. 1

Figure 16: Knob and tube wiring, ex. 2

- Although the knob and tube wiring used may largely be no different from that used today, it consists of only a hot (black) and neutral (white) wire and no ground wire. Both wires must run separately to fixtures as opposed to modern wiring which is contained within a single plastic sheathing. In addition, junction boxes and metal raceways for housing electrical connections were seldom, if ever, used in knob and tube wiring.

- Although it is a workable system, and safe when installed and used properly, there are some concerns with this knob and tube wiring system. For example:

- there is no ground wire (for more modern lifestyle requirements and safety),
 - a fear exists that the black and white wires can make contact (a potential fire and safety hazard),

- the rubber and cloth insulation around the knob and tube wiring breaks down over time (a potential fire and safety hazard),
 - costly to maintain, or even install this type of wiring today, and

- insurance companies are now refusing to provide home owners insurance for homes which use this type of wiring system.

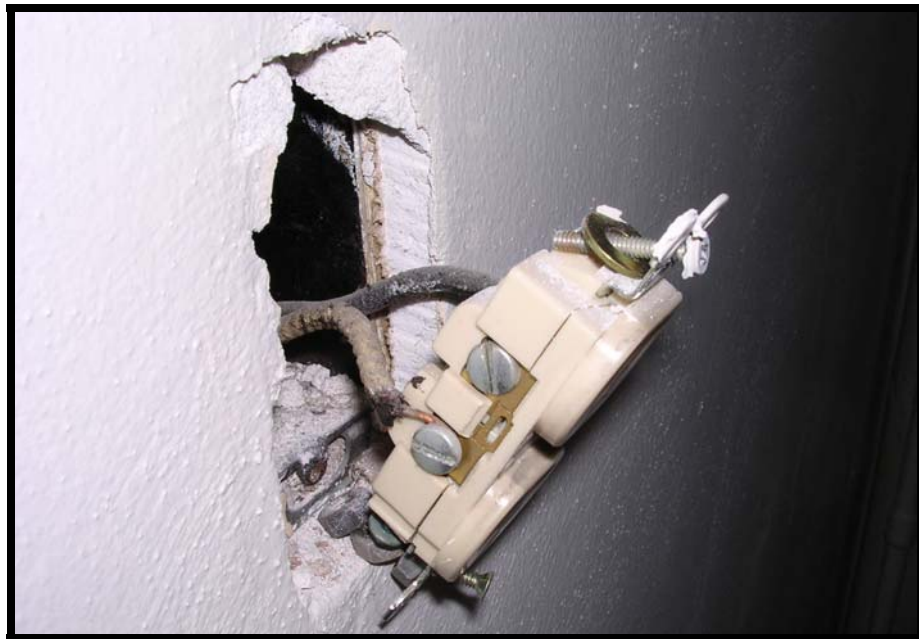
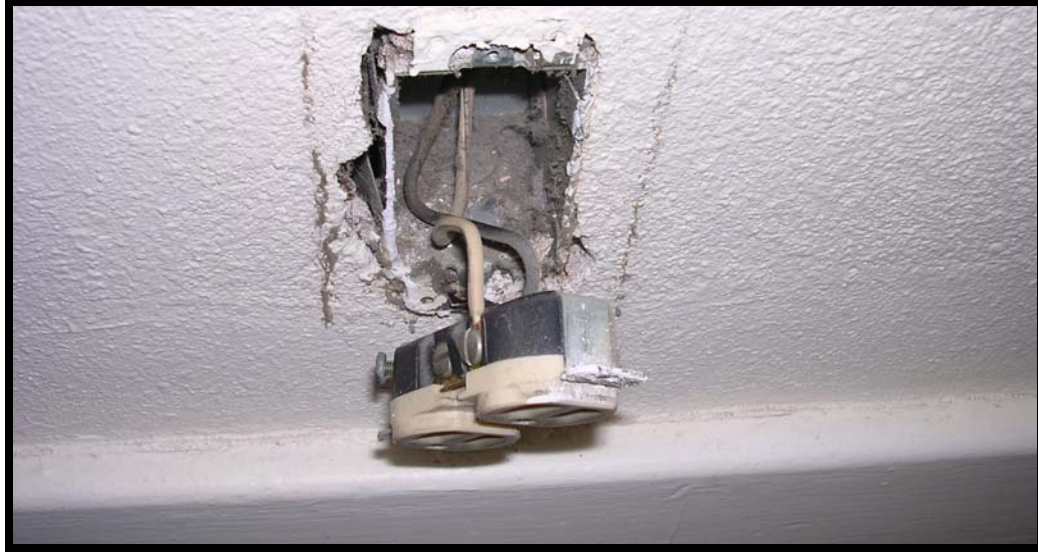
- (NEC 250-79 & NEC 250-114(a)) Improper or no connections of bonding wires to boxes or equipment; Grounding receptacles only had a neutral and a hot connected, and require either a ground connection, or a GFI receptacle.

Figure 17: Non-grounded receptacle, ex. 1

Figure 18: Non-grounded receptacle, ex.2

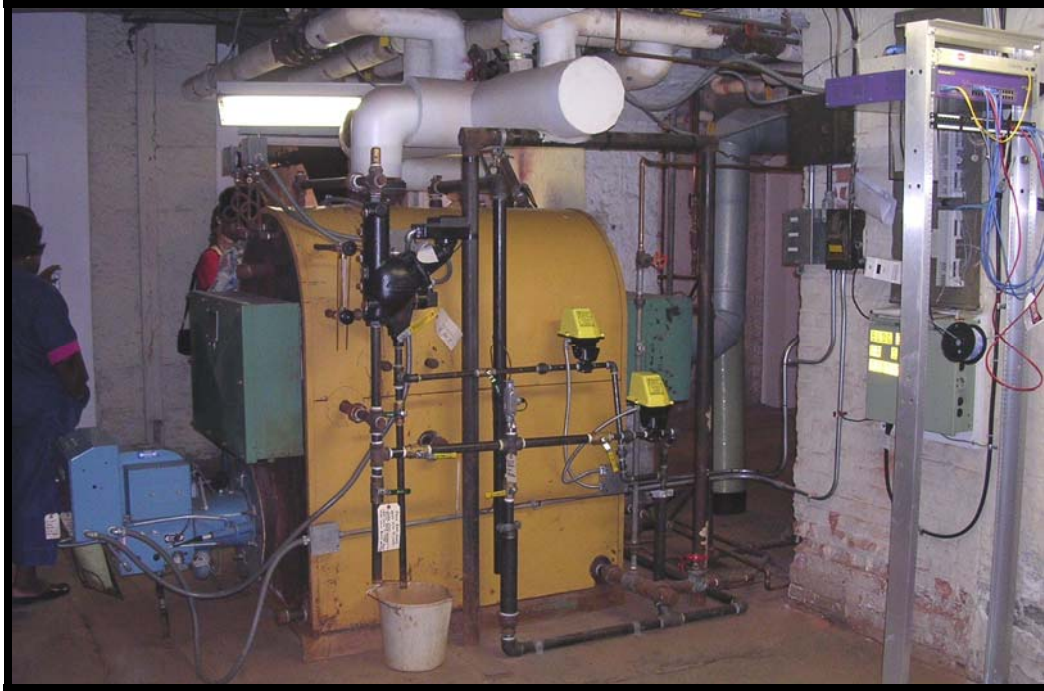
- The existing heating system consists of a natural gas fired steam boiler located in the basement, steam and condensate piping, and radiators (located on the first two floors).

Figure 21: Quarters 1 Steam Boiler

- Due to the construction of the structure, a central forced air furnace, ductwork, and condensing unit system is not feasible as a retrofit approach. The RIA does not want to pursue the use of natural gas as the source of heat but instead requests geothermal heat pumps to be used. With this in mind, the recommended replacement of the existing heating and cooling systems would include the possible use of heat pumps and ductwork in the basement to heat and cool the first floor; and individual heat pumps and geothermal loop piping in place of the steam and condensate piping for the second and third floors. This would allow for greater flexibility in zone control of the building, especially if an entire floor were unoccupied.

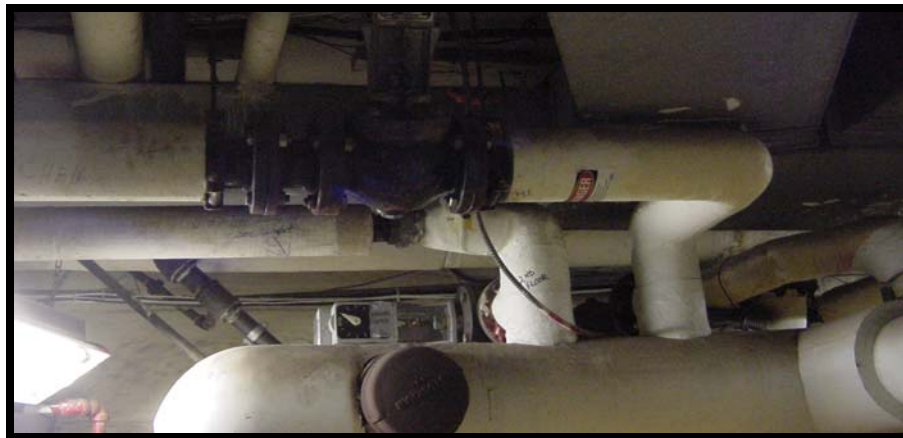
Figure 22: Steam and Condensate Piping – Asbestos Insulated

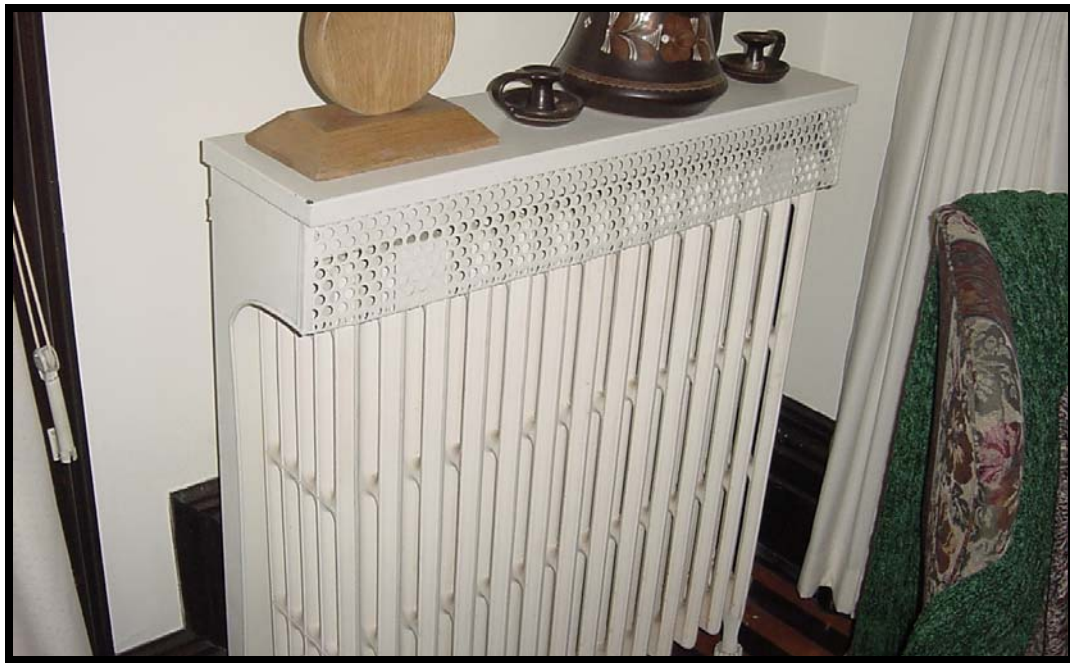
Figure 23: Typical Cast Iron Radiator
